Manhole Inspection Summary

Manhole # S03EE2008MH

Insp Date: **7/20/06 10:06 AM**

Location Address: **2853 BANE BERRY CT**

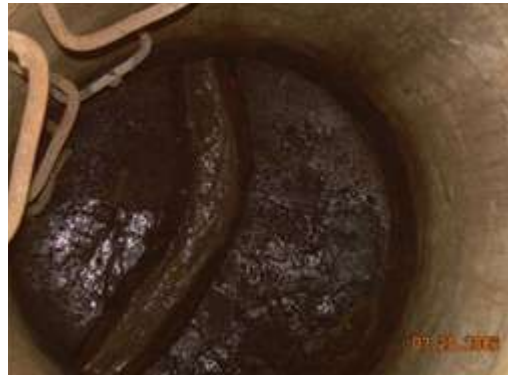
Top View

Adjustment infiltration. Evidence of surcharge - Bench debris.

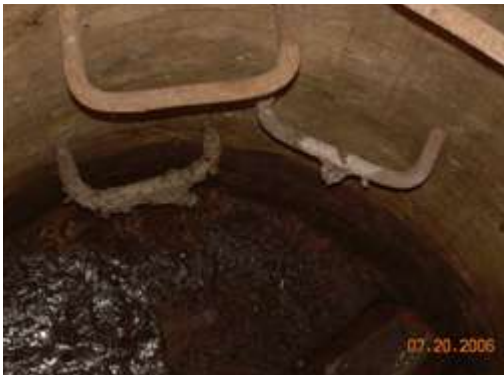
Evidence of surcharge

Evidence of surcharge.

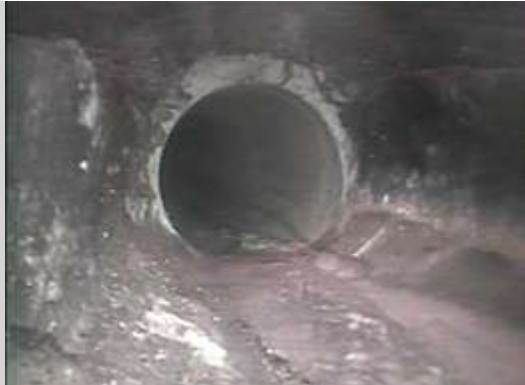
8 in. Circular Gravity Sewer Pipe Out @ 12 O'Clock

Invert Depth: **9.98** (ft.) Flow Characteristics: **Fast**

Infiltration: **None** Pipe Seal Cond: **Unknown**

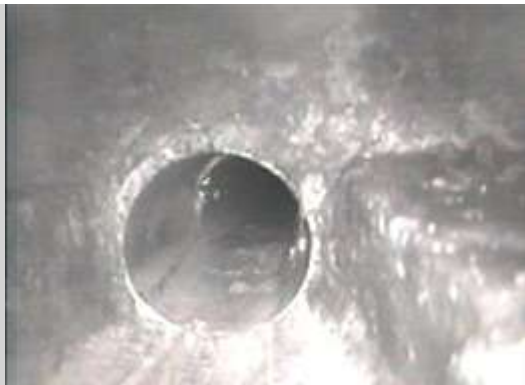
6 in. Circular Gravity Sewer Pipe In @ 7 O'Clock

Invert Depth: **9.75** (ft.) Flow Characteristics: **Fast**

Infiltration: **None** Pipe Seal Cond: **Unknown**
